Making the World's
Best-Selling Airplane
Even Better

**Understanding
the New
Widespread
Fatigue Damage
Rule**

Next-Generation
737 Fuel
Performance
Improvement

Lightning Strikes:
Protection,
Inspection, and
Repair

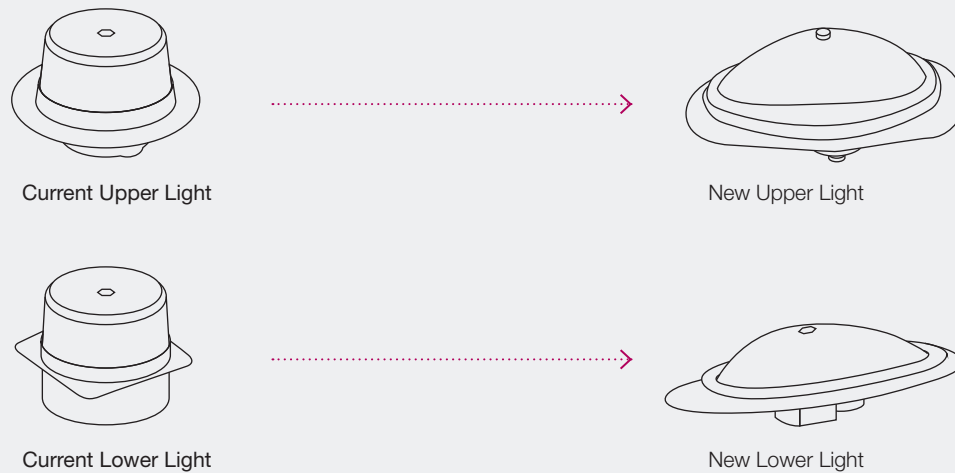
Figure 1: Aerodynamic-shaped anti-collision (AC) lights

New AC lights (right) are more aerodynamic than the previous lights (left).

Aerodynamic AC lights. Replacing the upper and lower red AC light assemblies with a more aerodynamically designed shape reduces airplane drag (see fig. 1). The upper skin was revised, and no electrical interface changes were required to accommodate the new AC lights.

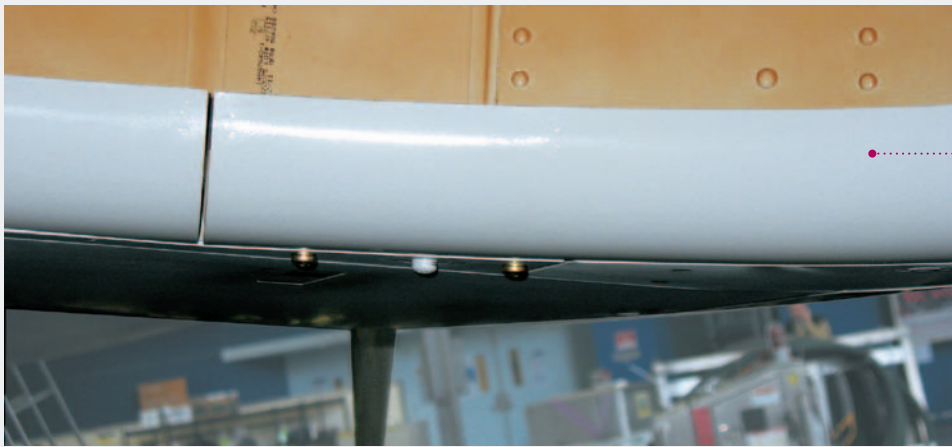
Figure 4: Ski-jump wheel-well fairings

The PIP includes five new contoured panels on the aft side of the wheel wells.

New Wheel-Well Fairing Design

Wheel-well fairings. The five aft wheel-well fairing assemblies have been recontoured to smooth the airflow near the main landing gear, reducing airplane drag (see fig. 4).

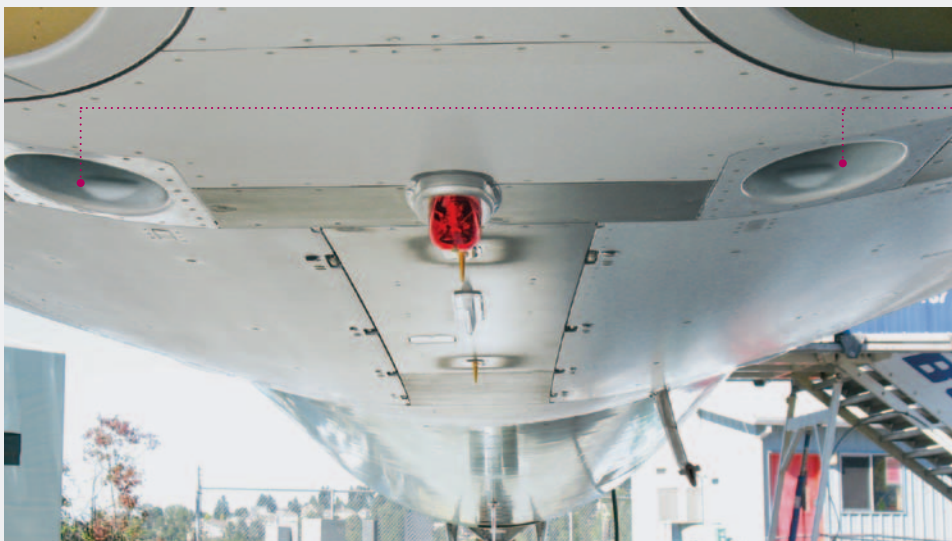
Figure 5: Newly configured exhaust vents designed to reduce drag

New Louvered Exhaust Duct

New ECS exhaust vent. The PIP also reduces drag by modifying the existing ram air inlet systems and adds new modulated ram air exhaust systems associated with the left and right air-conditioning packs (see fig. 5). The previous ram air inlet actuators have been replaced by new "smart actuators" that allow position feedback and communicate with the added ram air exit actuators. The new smart actuator is mounted at a slightly different orientation at the inlet than the current actuator, and the

The system — inlet and exit — is tuned to open and close together at a very specific relationship to optimize thrust recovery of the air exiting the exhaust louvers, reducing fuel burn of the airplane.

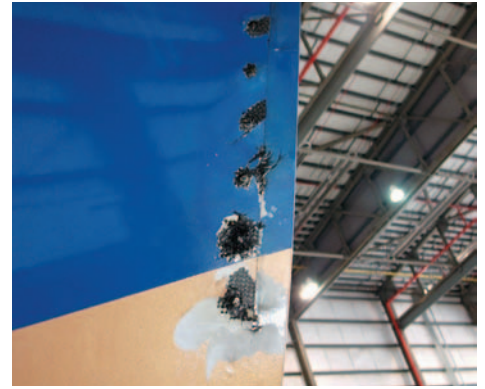
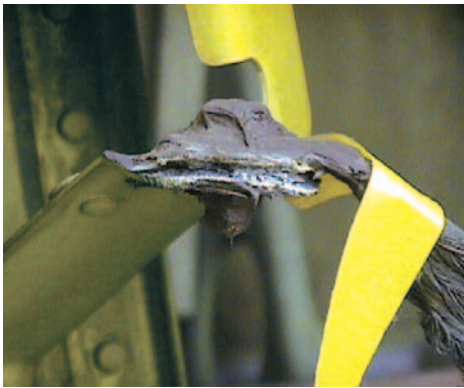
Figure 5: Lightning protection and strike damage

Clockwise from upper left: Lightning damage to a horizontal stabilizer, rudder, antenna, and bond jumper.

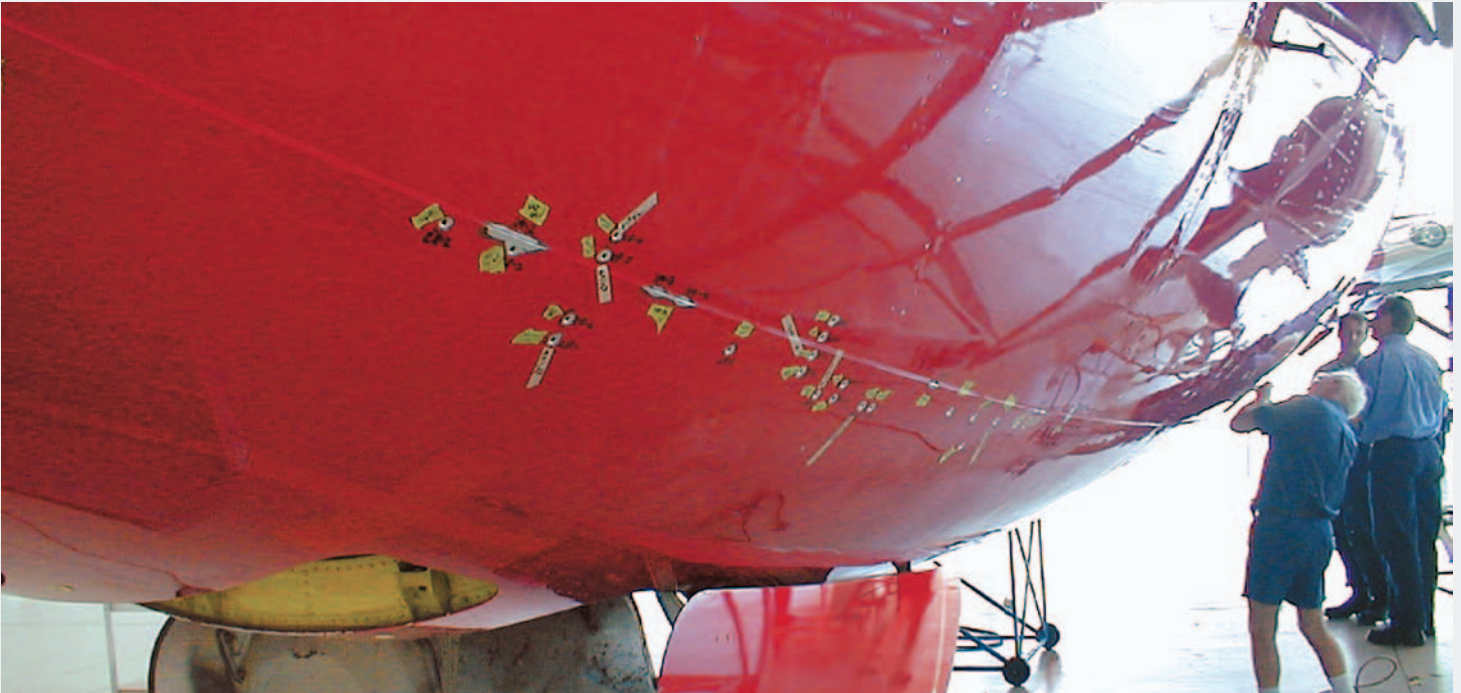
Figure 6: Damage caused by lightning moving along an airplane

When a lightning strike moves along an airplane, it can cause “swept stroke” damage.

Because the airplane flies more than its own length during the time it takes a strike to begin and finish, the entry point will change as the flash reattaches to other spots aft of the initial entry point. Evidence of this is seen in strike inspections where multiple burns are seen along the airplane’s fuselage (see fig. 6).

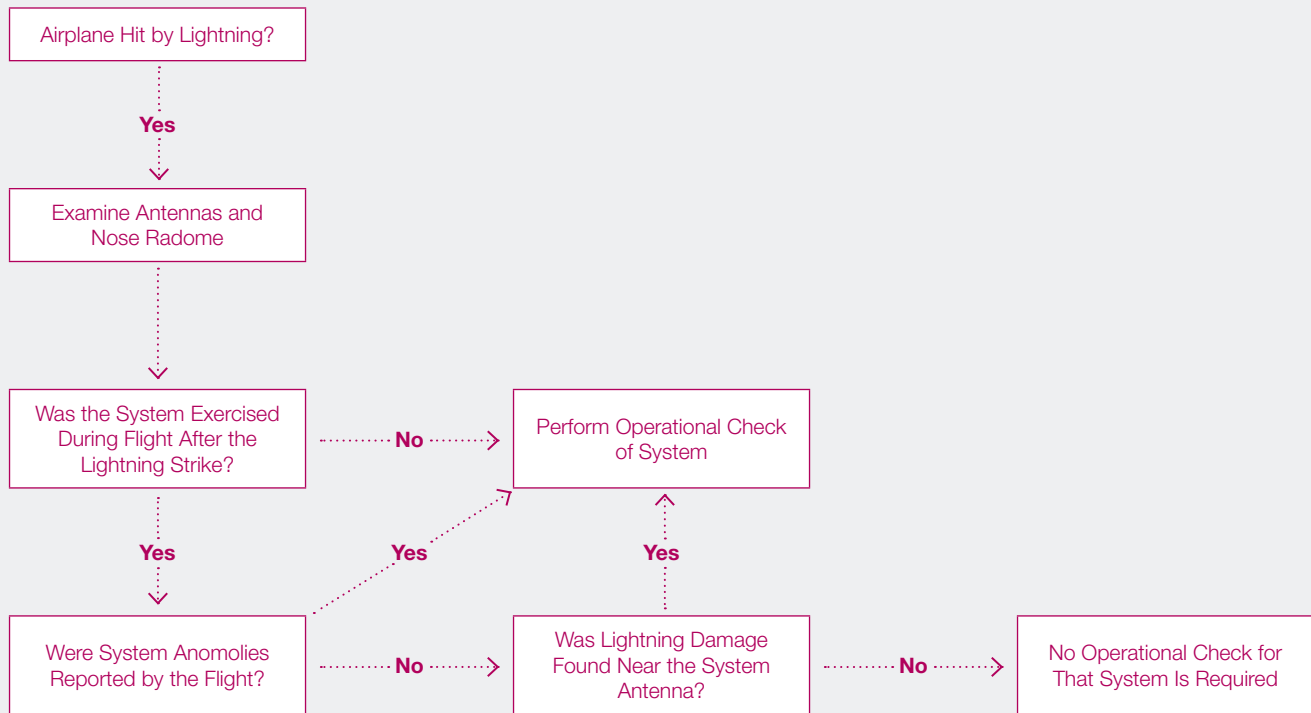
Figure 10: Conditional inspection flowchart of internal components

Boeing recommends that a lightning-strike conditional inspection be performed prior to the next flight to maintain the airplane in an airworthy condition.

Logic flow for inspection of internal components in maintenance procedures provided by Boeing follow a similar process (see fig. 10).
